Referee 2: Tom Walski

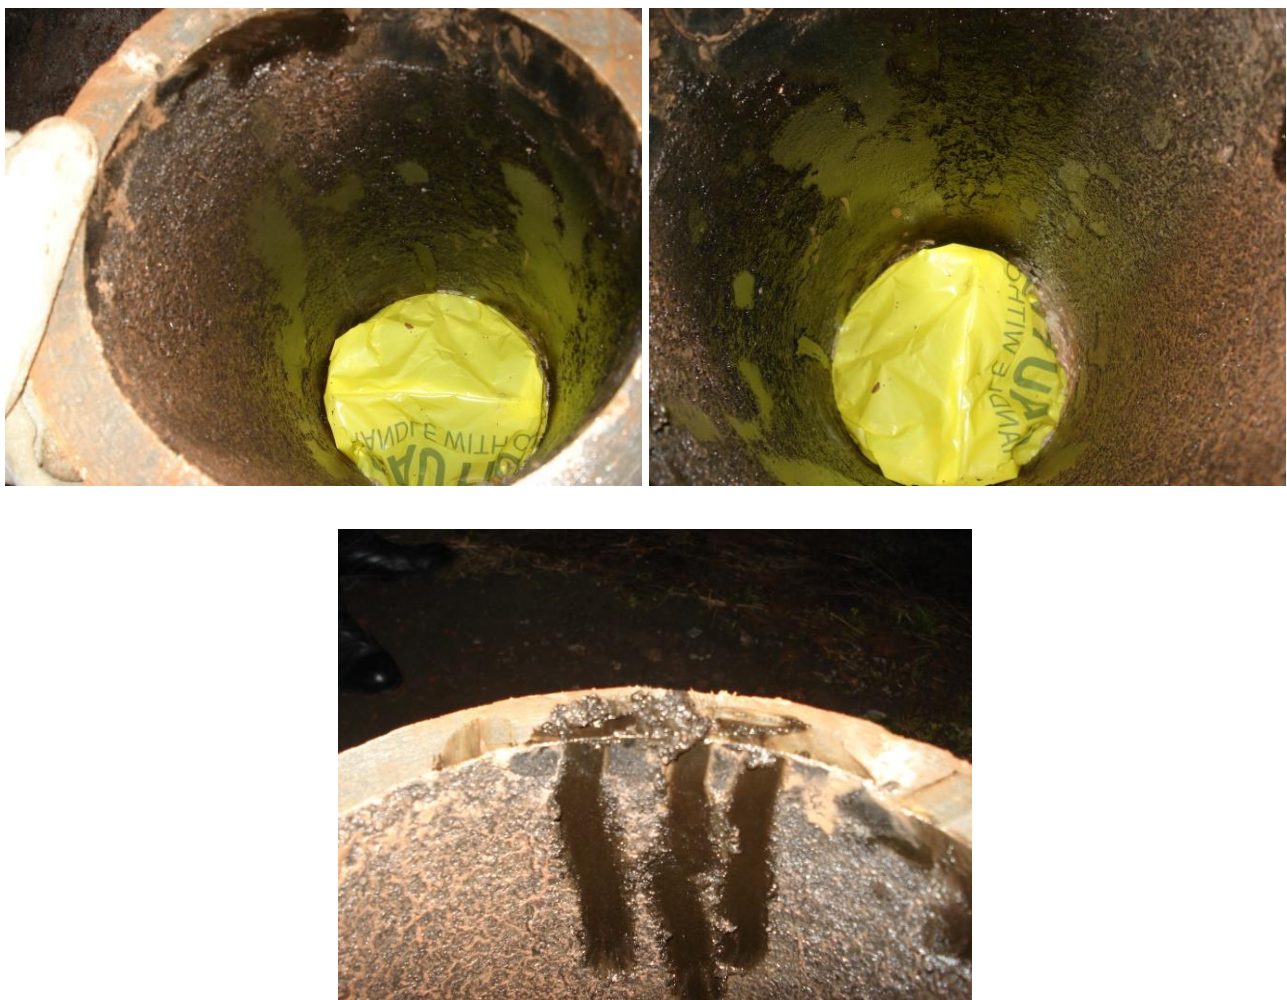
Figure 1 shows images of pre-intervention pipe cut out. Accumulated material can clearly be seen around the full pipe circumference, supporting the PODDS model concepts. The cut out was taken at the longitudinal low point (manuscript Figure 1a), such that all gravitationally driven self-weight settling processes that would have led to invert deposits were explored, with none being found.

Figure 1: Pre-cleaning intervention pipe cut out

C1 Ans: A pre-intervention pipe cut out was taken from the trunk mains low point (Figure 1a in the manuscript) to assess the pipe internal condition and amount of accumulated material present on the asbestos cement pipe wall.

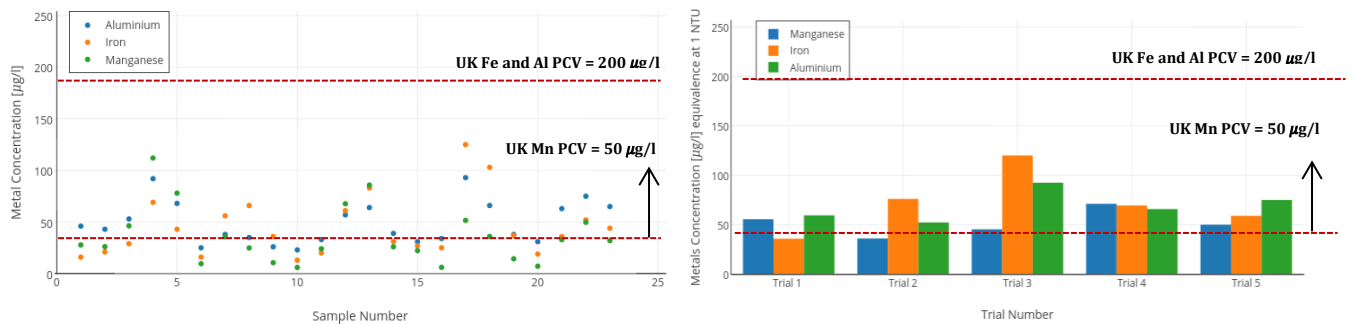
Results of metal samples during trials are shown in figure 2. Figure 2a shows all metal samples during trials where the concentration of manganese (Mn) was high and occasionally exceeding the UK regulatory prescribed concentration value (PCV) value of 50 µg/l. Iron and aluminium concentrations in the bulk water is also shown to be significant, although well below the UK PCV limit. Figure 2b presents the results for calculated metal concentrations for an equivalent 1.0 NTU limit. Manganese PCV is likely to be exceeded during all trials at this threshold suggesting high Mn content in the bulk water. From this it could be suggested that the accumulation or fouling effects are driven by manganese and other metal (e.g. iron and aluminium) precipitation from the bulk water which is consistent with previous research findings (Boxall et al., 2003; Husband and Boxall, 2011; Seth et al., 2004)^{1,2,3}. However, a complete conclusion about inorganic particles responsible here for discolouration risks cannot be drawn from this sampling study alone as undisturbed sampling data from trunk main were unavailable. Also the previous work has indicated that biological processes impact on material accumulation and hence its influence discolouration risks as well (Gauthier et al., 1999; Husband et al., 2016)^{4,5}.

Figure 2: a) Metal concentration in bulk water during trial durations, b) metal concentration equivalence at 1.0 NTU
